Survey of items

91 Driver's seat

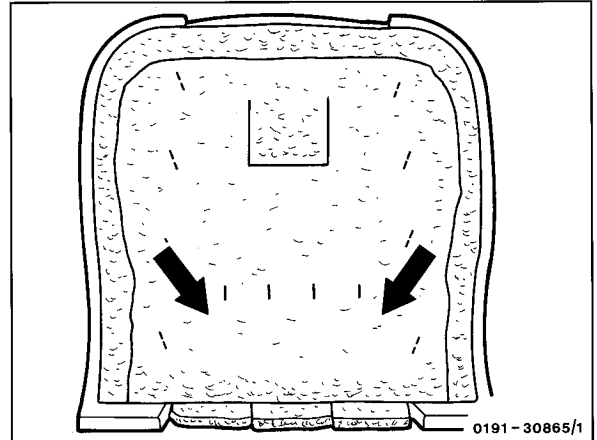
91-87111 Driver's seat cushion worn out (vehicles from production period 01/87-08/87).

Bottom layer of standard rubber hair support parting from upper layer (Fig., arrows). Supplier's fault.

Replace rubber hair support.

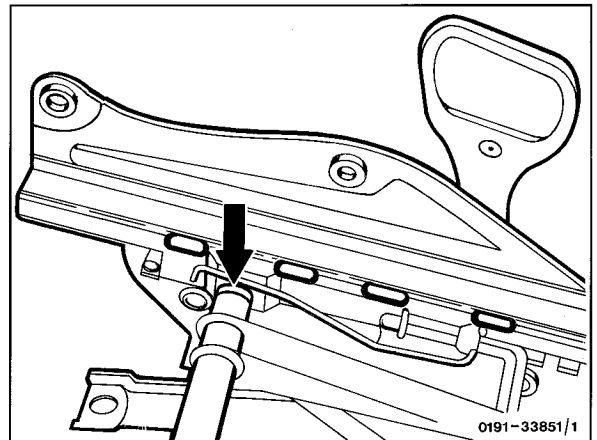
91-88011 Noises from mechanical seat adjusting device when driving around bends.

Plastic bushings in transverse tube of longitudinal adjusting lever are causing noises.

Lubricate plastic bushings left and right on removed seat.

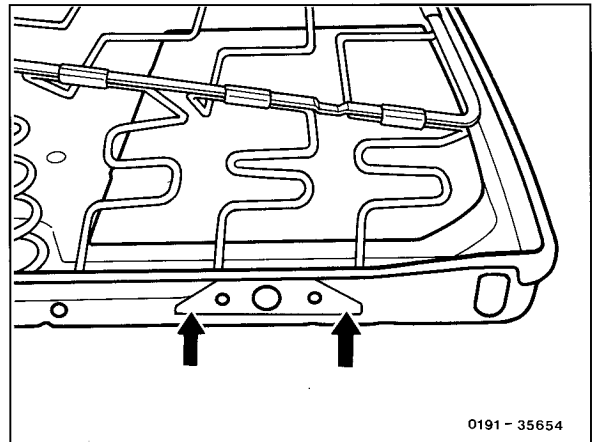
91-88021 Noises from seat cushion when driving around bends.

Reinforcing panels of cushion frame are rubbing against seat adjuster.

Straighten projecting ends of the reinforcement plate, lightly file or grind if necessary and grease with door lock grease, part no.

001 989 13 51 10.

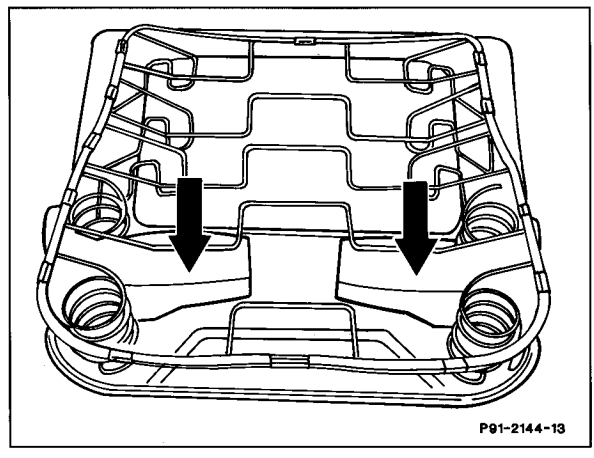
- 91-89051
- a) Driver's seat cushion floats or tilts laterally when driving around bends.
 - b) Driver's seat cushion cover damaged on side in the area of tilt adjustment mechanism.

- a) Inadequate lateral guiding of cushion frame.
- b) Cover fabric is jammed in at the inclination adjusting device with heavy load on the seat cushion.

- a) and b) Install foam material wedge (2 off) left and right in the cushion frame.

Part no. 124 910 16 75

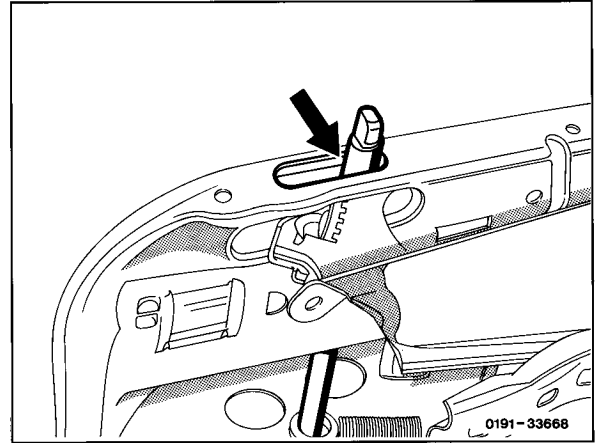
91-89071 Noises on tilt adjustment mechanism

- Tilt adjusting shaft rubs in oblong hole of cushion frame, front.
- Backrest connection rubs against cushion frame or seat adjuster, rear.

- Grease both oblong holes with MB door lock lubricating grease, part no. 001 989 13 51 10. Actuate tilt adjusting shaft several times.

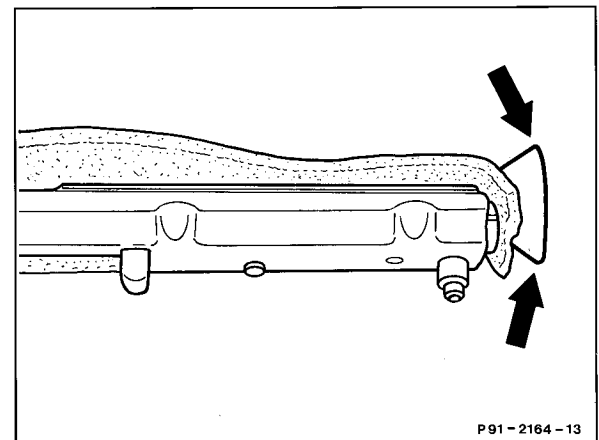
91-89072 Scratching noise in upper backrest range when backrest upholstery is energetically depressed.

Plastic funnel of headrest guide strip rubs against rubber hair mat.

Remove headrest guide strip. Mask sharp edge of plastic funnel with self-adhesive felt (40 x 2), part no. 001 983 23 10 (arrows).

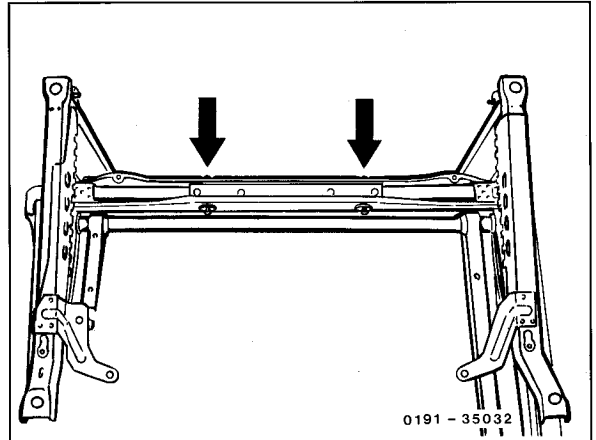
91-89073 Noises from manual seat height adjusting device.

Lever for seat height not lubricated at pivots (2 bolts).

Lubricate bolts on cross member.

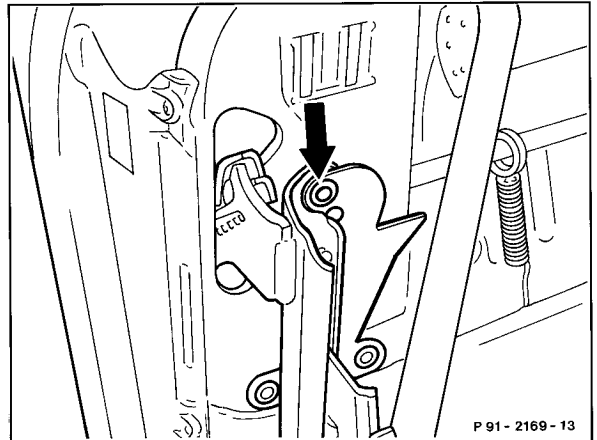
91-89074 Noise from seat adjuster when driving around bends.

Rivet connection on front leaf spring loose.
Reason: Hole diameter for rivet too large.

Install modified leaf spring, part no. 124 919 03 64/04 64 (with hole diameter 6.5 mm), using rivet 910002 006104. In an emergency, the rivet can also be replaced by a bolt M6 x 10 and nut M6.

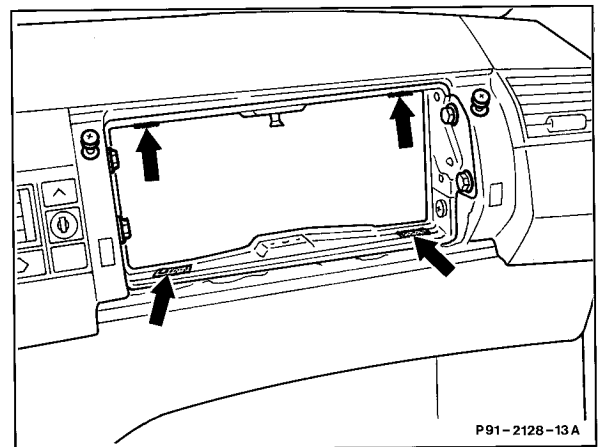
91-89111 Clattering noises on front passenger airbag unit.

Front passenger airbag unit knocks against installation frame.

Remove front passenger airbag unit (pay attention to safety prescriptions). Cut out 4 felt strips approx. 20 x 25 mm from self-adhesive felt (40 x 2), part no. 001 983 23 10, and glue to inside of installation frame (arrows).
