## 07.5—503     Removing and preventing coating on breaker points

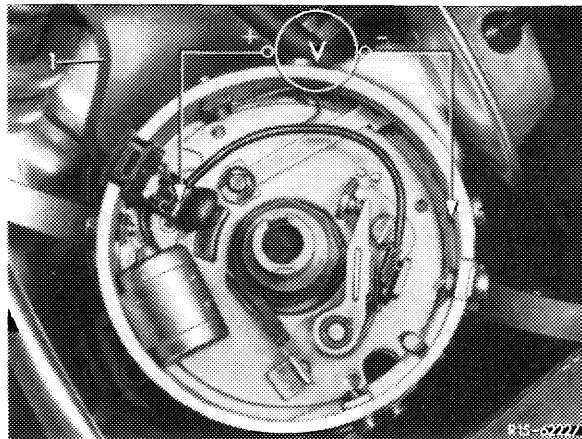
1 Control line with capacitor

A blue or dark grey coating on breaker points of transistorized ignition systems may result in misfiring when in a progressive stage due to the insulating characteristics of the coating — no matter whether a GE or a SI switchgear is installed. Pertinent complaints have resulted in unjustified exchange of switchgear.

With contact closed, the voltage drop may amount to **0.5 volts**. A larger voltage drop indicates the beginning of a coating.

- a) Exchange breaker points (refer to repair instructions).
- b) Remove control line with capacitor (1) and replace by **shielded control line without capacitor**.

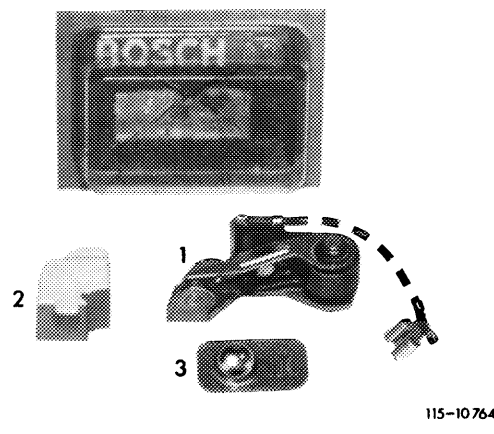
Arrow: spot to be greased

When renewing breaker points, be sure to coat slide piece (arrow) with a selected grease wedge (special grease Bosch Ft 1 v 4). If no grease is applied, the increased wear of the slide piece will increase the closing angle (smaller contact gap). This in turn will favour the formation of a coating and may result in misfiring.

Mount breaker point cap to protect contact against grease, oil or dirt particles.

To guarantee that the slide piece is greased and the protective cap is mounted when the breaker points are installed, breaker points are supplied from now on together with a grease capsule and a protective cap.
