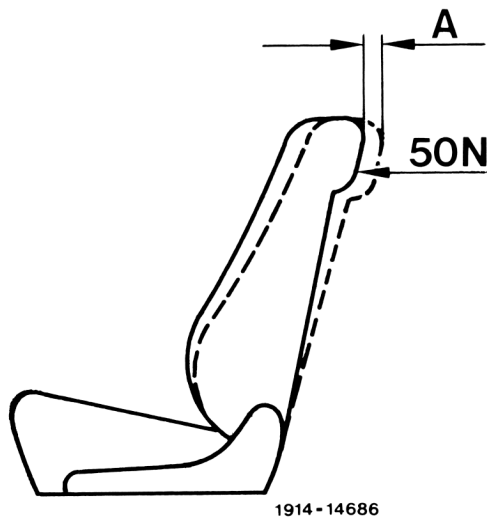
In the event of complaints regarding noises from the front seats first determine whether the noise is caused by the seat cushion, backrest or seat adjustment mechanism. Perform these checks with the front seats **installed**. Before removing the seats also check the play in the reclining seat fitting by moving the backrest (figure) and note dimension "A".

1 Replace backrest frame if the play in the reclining seat fitting is greater than 30 mm. If the play is less than 30 mm check whether the springs can be moved in relation to one another. If so replace the backrest frame in this case as well. For this purpose remove the front seat and take off the cover for the backrest frame (RI 91-182).

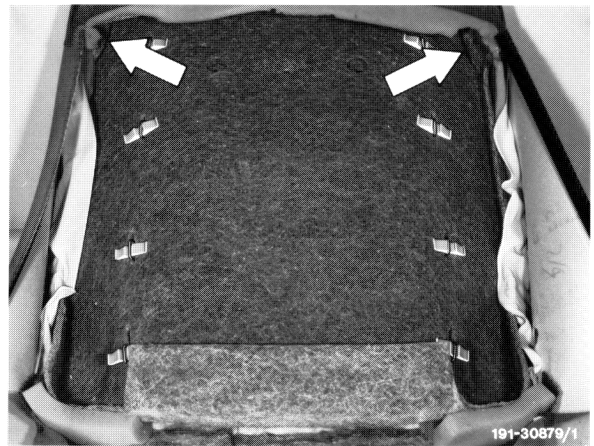
2 If the stop on the rubberized fiber matting rubs against the top of the backrest under load, replace rubberized fiber matting.

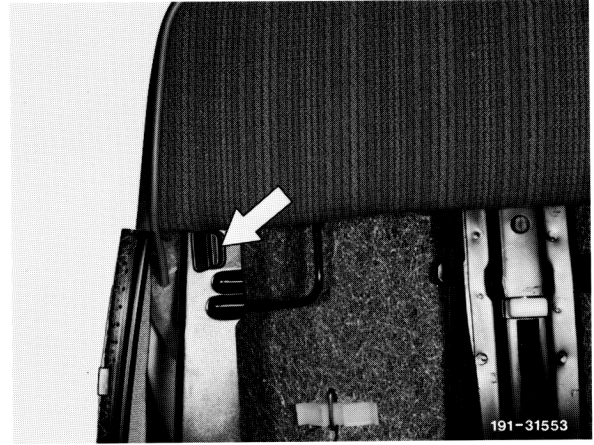
Mounts for springs loose at side of backrest frame.

Bend retaining lugs down tighter with screwdriver.

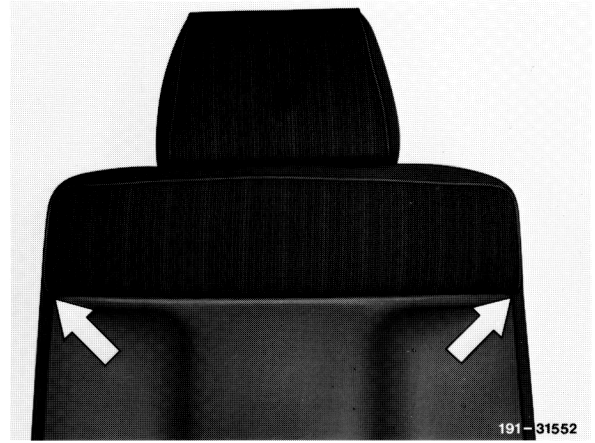
Piping on left and right rubs against tensioning element at top.

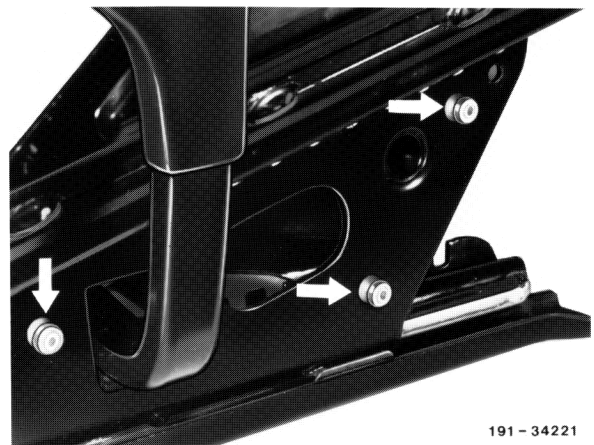
191 - 34221

Seat adjustment mechanism, 2nd version

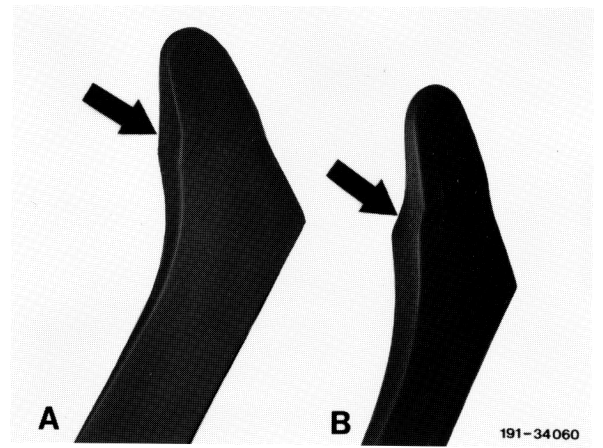
B Panel filed down

3 File down panelling on reclining seat fitting so that backrest cover cannot be damaged.
