All models

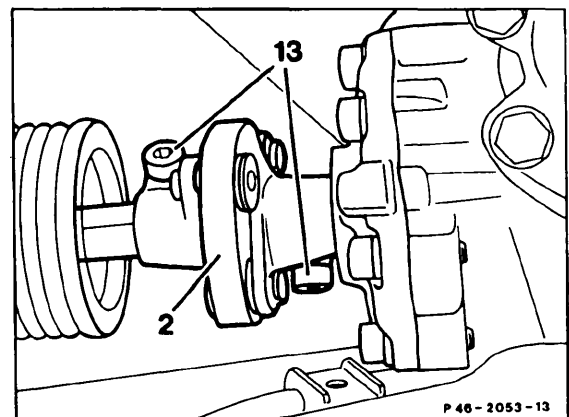
Models 124 (except 124.034/036), 129, 201

- On all models starting 04/1984, check play of steering coupling or of both flexible couplings (2).

2 Flexible coupling

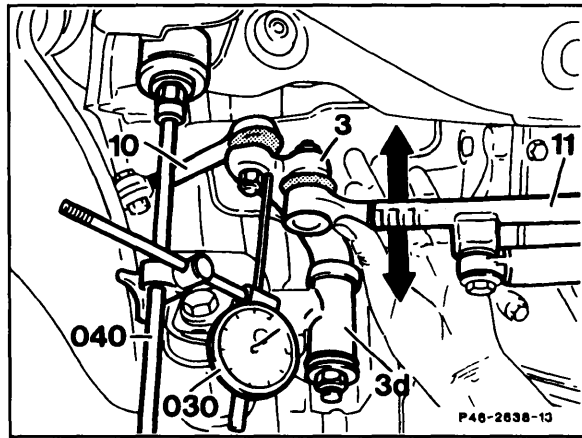
All models except 140

- Check mounting of idler arm (3) in rubber bushings, using dial indicator as necessary (SMS Job No. 46-0110). If play is greater than 0.5 mm, replace rubber bushing (SMS Job No. 46-0520) on separate order.

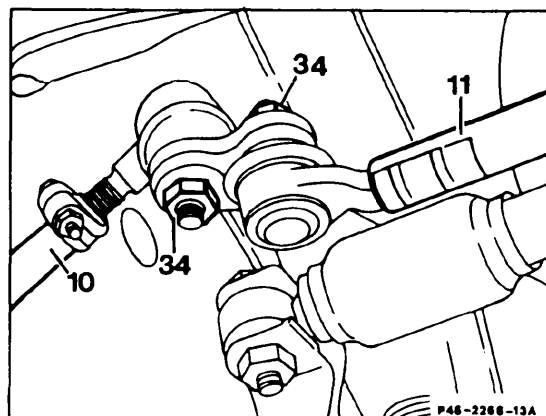
- With vehicle resting on wheels, move steering left and right approx. 100 mm while checking the following ball joints:
- Tie rod end (10) ball joints.
- Tie rod (11) ball joints.
- If play is found, replace the appropriate ball joint.
- Check condition of rubber boots.

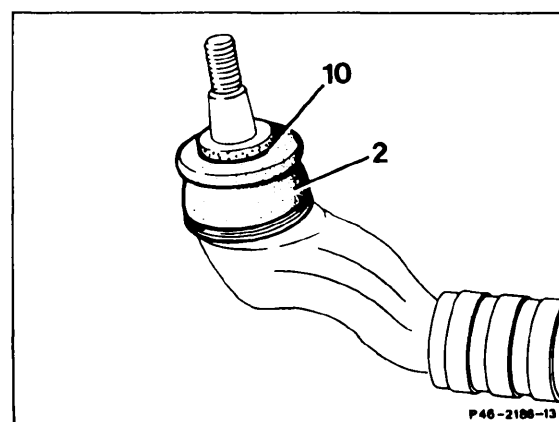
If a damaged rubber or plastic boot is found, replace affected joint immediately, since penetrating dirt will destroy joint in a short time. **Replacement of only the boot is permitted only if no dirt whatsoever has entered the joint.**

2 Rubber boot
