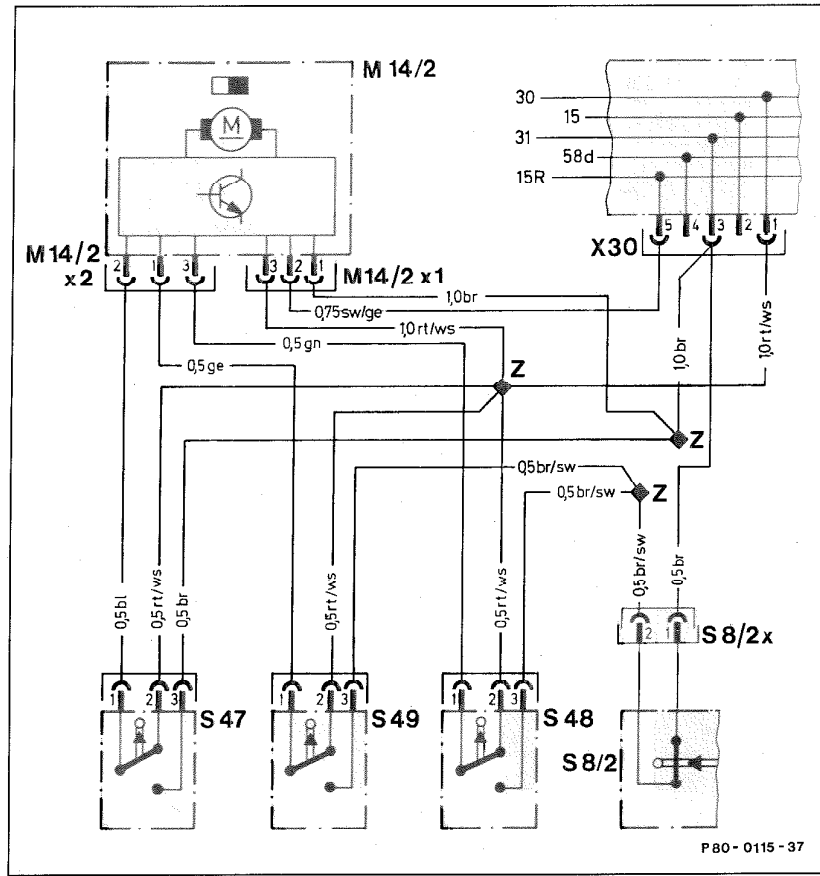
P80-0115-37

## B. As of approx. 09/85 to approx. 04/86

| M14/2 | Supply pump (CL/OSB) | S47 | Left front door actuator |
| M14/2x1 | Supply pump voltage supply connector (CL/OSB) | S48 | Right front door actuator |
| M14/2x2 | Supply pump control line connector (CL/OSB) | S49 | Trunk lid lock actuator |
| S8/2 | Warning buzzer contact (exterior lamps/CL) | X30 | Accessory equipment connector block |
| S8/2x | Connector, warning buzzer contact lighting/central locking system | Z | Connector sleeve (solder joint in harness) |

Black/yellow cable from M14/2x1 jack 2 to X30  
jack 5 is only installed with orthopedic backrest.

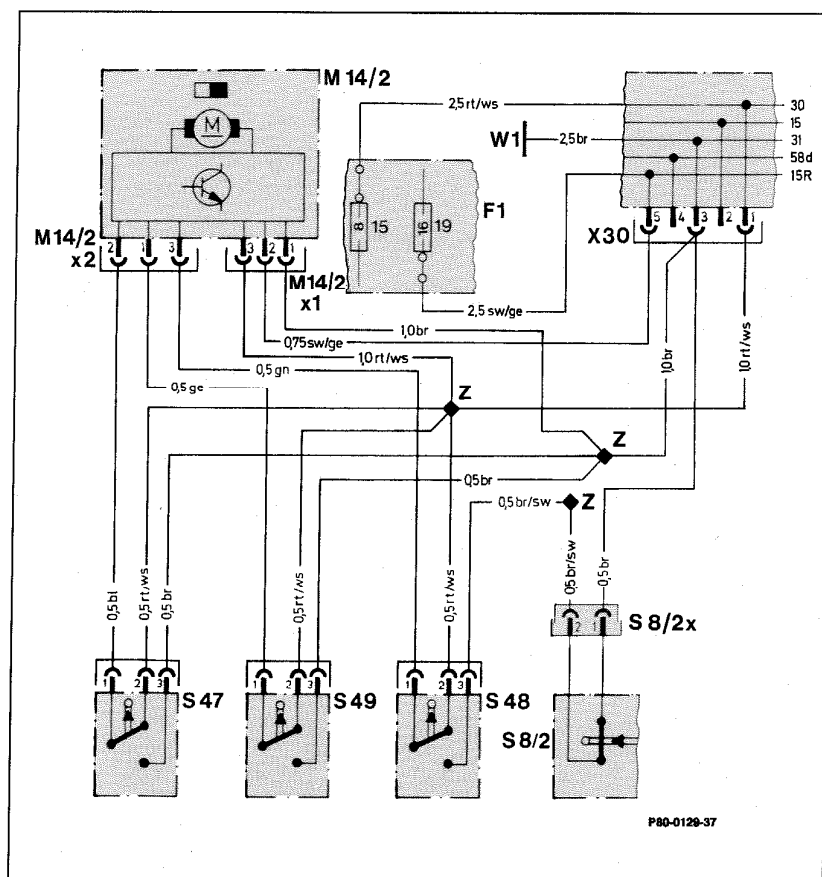
P80-0129-37

**C. As of approx. 05/86**

| F1 | Fuse and relay box | S47 | Left front door actuator |
| M14/2 | Supply pump (CL/OSB) | S48 | Right front door actuator |
| M14/2x1 | Supply pump voltage supply connector (CL/OSB) | S49 | Trunk lid lock actuator |
| M14/2x2 | Supply pump control line connector (CL/OSB) | W1 | Main ground (behind instrument cluster) |
| S8/2 | Warning buzzer contact (exterior lamps/CL) | X30 | Accessory equipment connector block |
| S8/2x | Connector, warning buzzer contact<br>lighting/central locking system | Z | Connector sleeve (solder joint in harness) |

**Black/yellow cable from M14/2x1 jack 2 to X30 jack 5 is only installed with orthopedic backrest.**
