Important information on repair work and following accidents

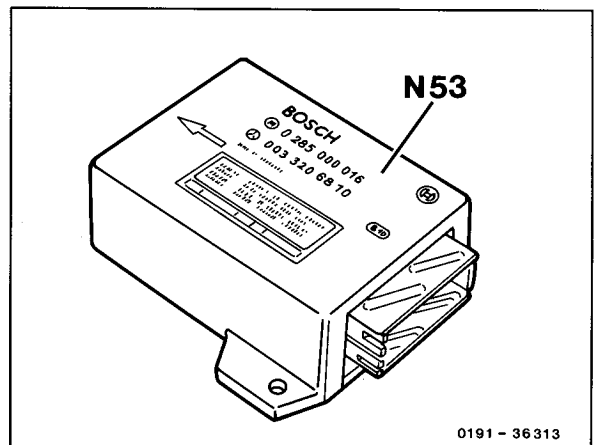
The roll-over bar control unit contains approx. 1.5 g of mercury. For this reason proper disposal is required according to the waste disposal laws (see microfiche Information on maintenance, care and repair, item 00-0400).

Part containing mercury:

Roll-over bar control unit

Workshops without any possibility for recycling components containing mercury can send these parts back to the Sindelfingen plant, Department KGA, Abladestelle (unloading point) 042 within the scope of the parts return service.
